PIPING

Process Valves

1Q-2007 D&R SHUTDOWN – NHT

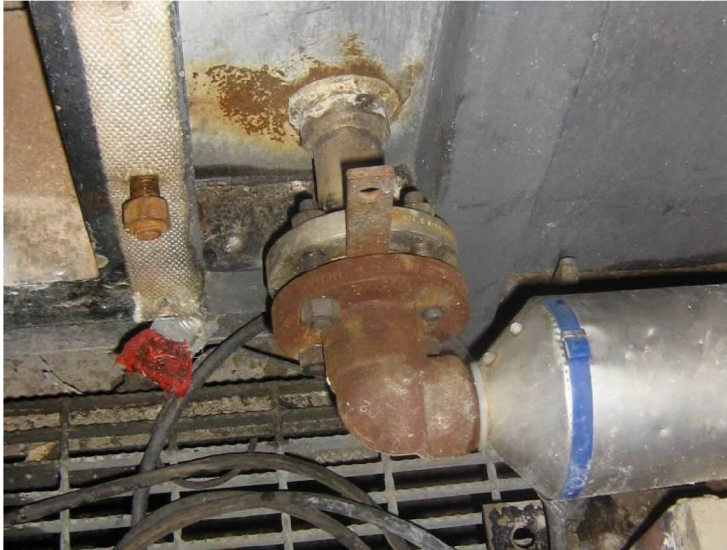
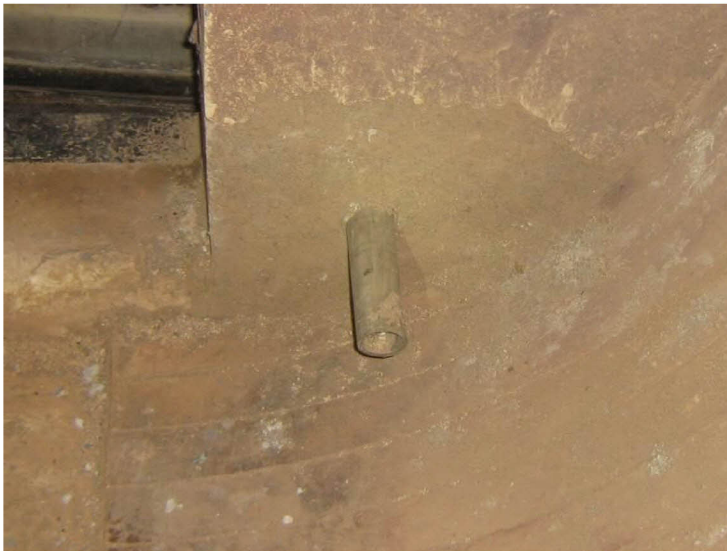
**F-447 TAW 6509 four steam snuffing nozzles are corroded to failure
BH202-E1
26206311**

The four (4) snuffing steam nozzles were corroded due to carburization. They were replaced during the shutdown.

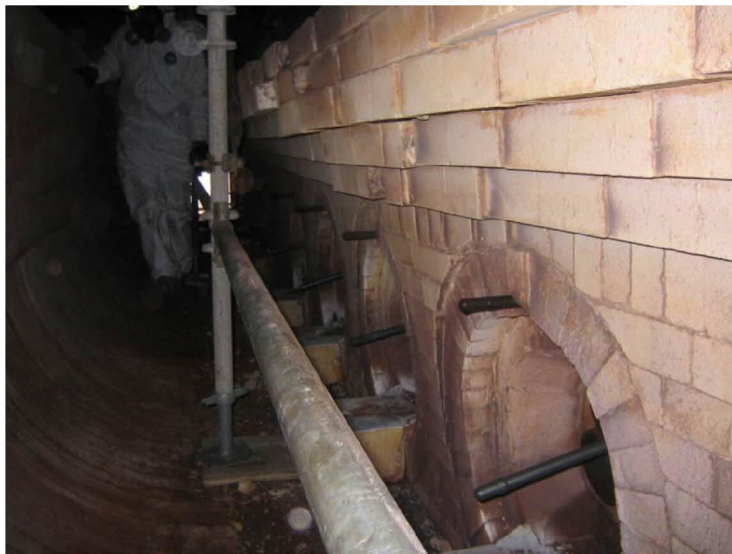
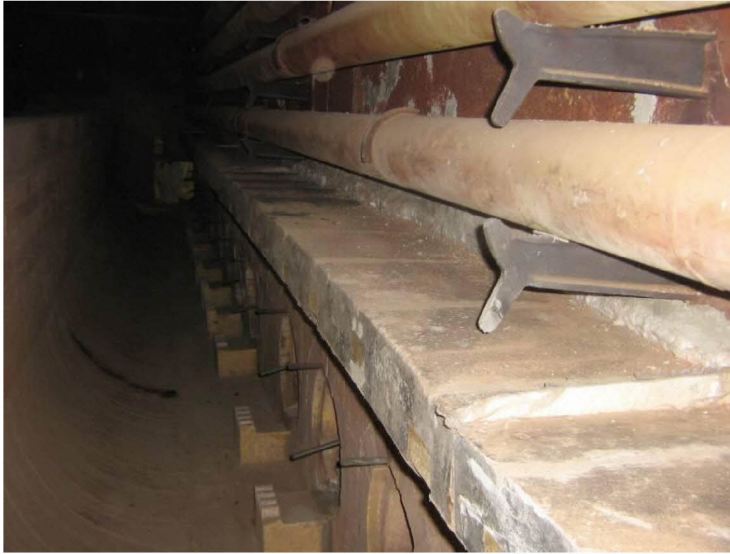
**F-447 TAW 6515 Refractory Repairs/Partial Replacement of East Corbel
BH202-E2
26206311**

The corbel support for the ledge directly below the first radiant tube had failed due to distortion of the steel wall skin and structural steel used to support the corbel. The 4" x 4" x 1/2" steel angle was stitch welded in a continuous piece along the entire length of the wall. When this piece grew due to thermal expansion, it bowed outward toward the center of the furnace and pushed the refractory away from the wall. The repair of the structural steel replaced this angle with 4' sections spaced 1" apart. The 2" x 2" x 1/4" angle originally used as a refractory anchor was removed. The existing 3" x 2" x 1/4" steel angle was left in place. Afterwards, JT Thorpe installed anchors and casted the ledge in place.

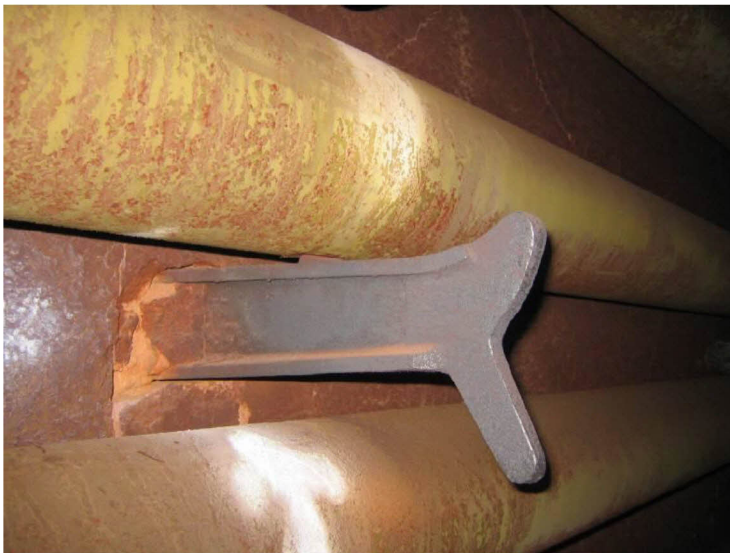
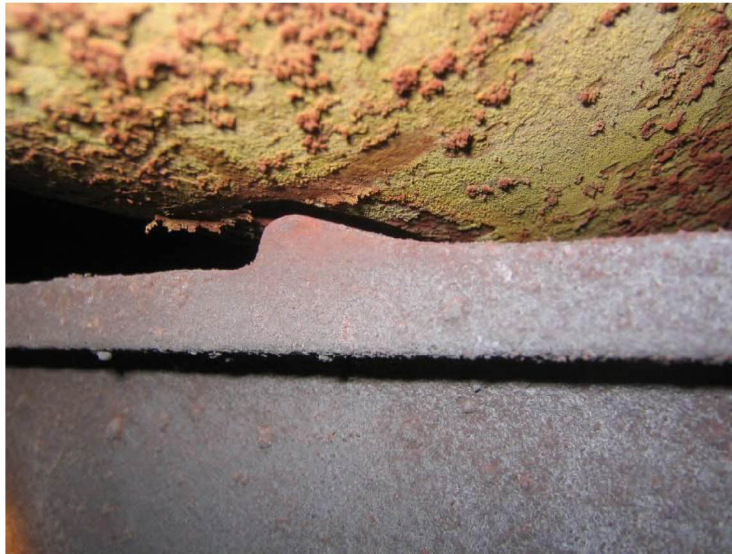
**F-447 TAW 6547 Tube/Hanger Impingement
BH202-E3
26206311**

Engineering found grooves in two furnace tubes in F-447. These grooves were a result of misalignment of the top loop on the east wall of the furnace with the tubes lying on the hanger inboard restraint nubbin for an unknown period of time. The thermal expansion of the tubes caused the nubbins to rub a groove into the tubes. Two grooves were weld-repaired and ground flush.

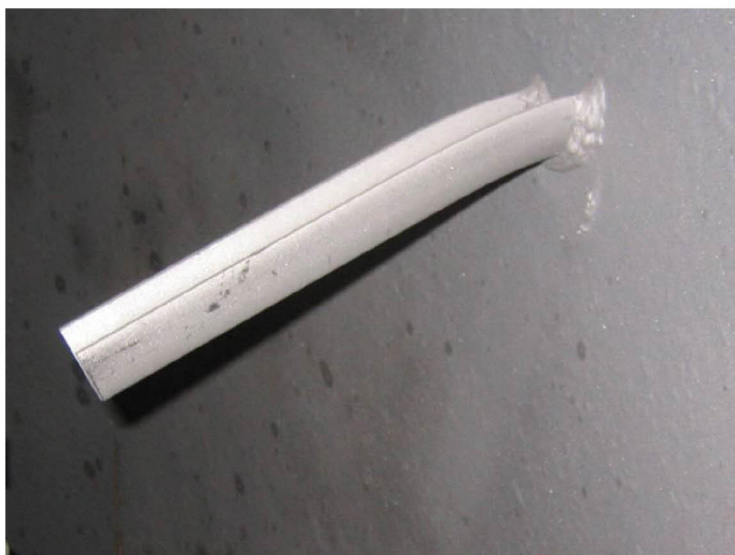
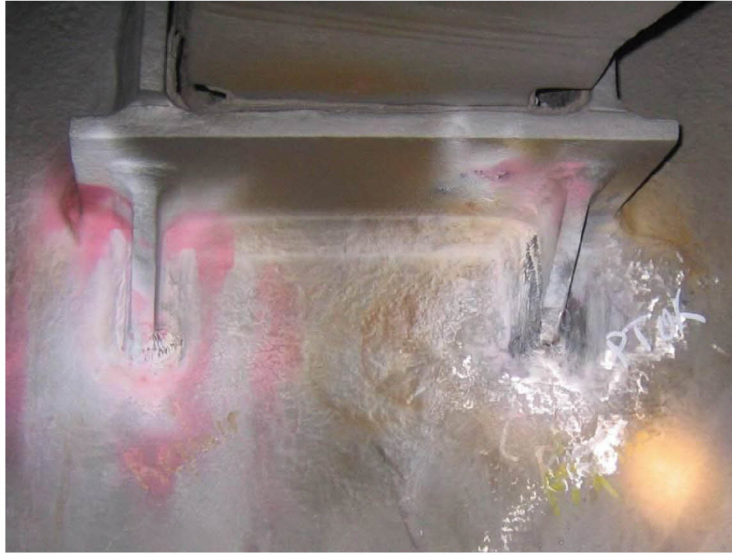
**EXTRA TAW 6434 R-410 TI SUPPORT & GUSSET WELD REPAIRS
BH301-E2
26203034**

Two vertical gusset welds on the beams supporting the catalyst bed were repaired and weld overlaid.

Also, the three (3) thermowells and TI's were replaced. One was bent and the other two were removed to inspect the nozzle internals. They were damaged during removal and replacements were ordered from O'Brien Ironworks.

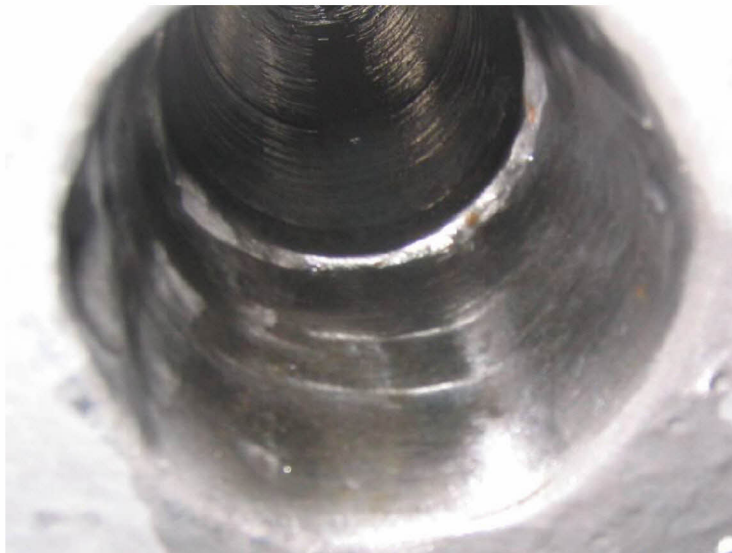
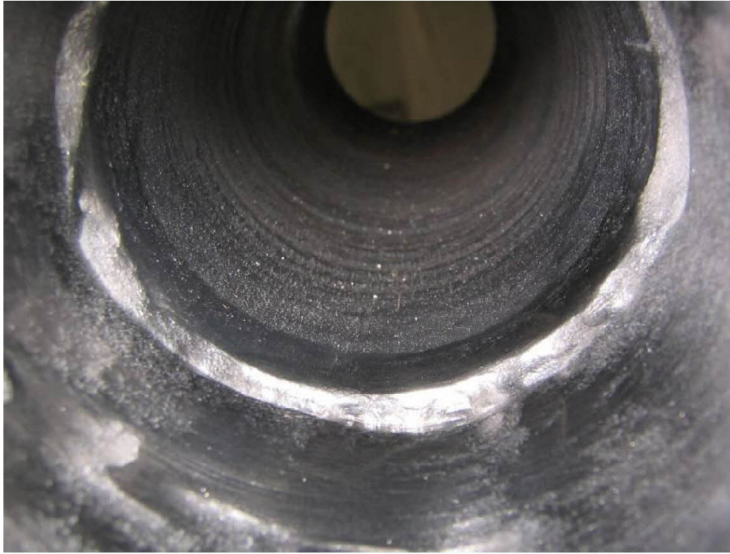
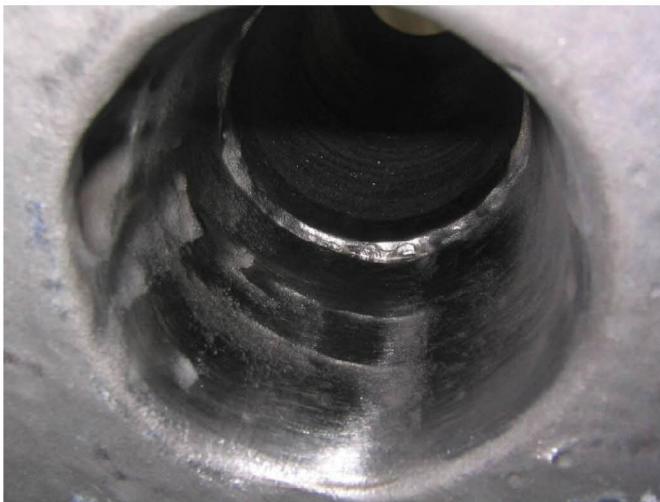
Prior to internal inspection, the reactor was grit blasted by Redwood. The “unused” thermowell nozzle and PI nozzle were cleaned and inspected. At first, it appeared there was internal corrosion of the full penetration weld on the “paste-on” nozzles (similar to the weld pitting seen on the support gussets elsewhere in the reactor). After further inspection and analysis by a corrosion specialist (Dave Cooke), pressure vessel specialist (Dave Bosi), inspection (Joe George), and engineering (Ken Mertes), it was determined that the weld was not corroding. Instead, it appears there was a lip due to the difference in the nozzle and shell diameters. It also appears that the root weld may not have been the best quality. **However, during the next internal inspection of this reactor, the TI and PI nozzles shall be inspected to determine if any additional corrosion has occurred. Numerous photographs were taken of these nozzles.**

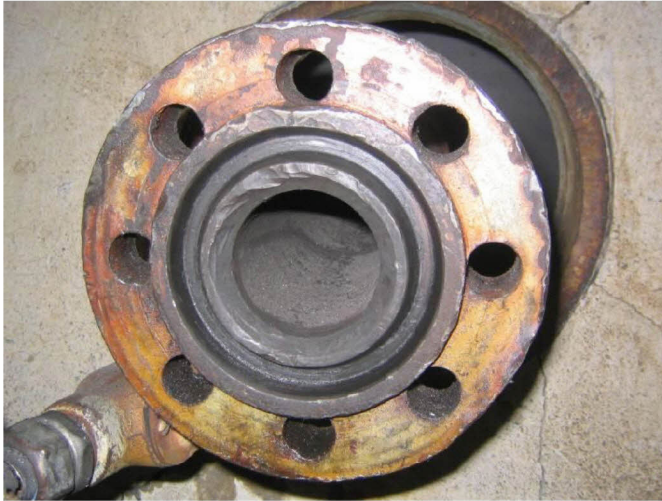
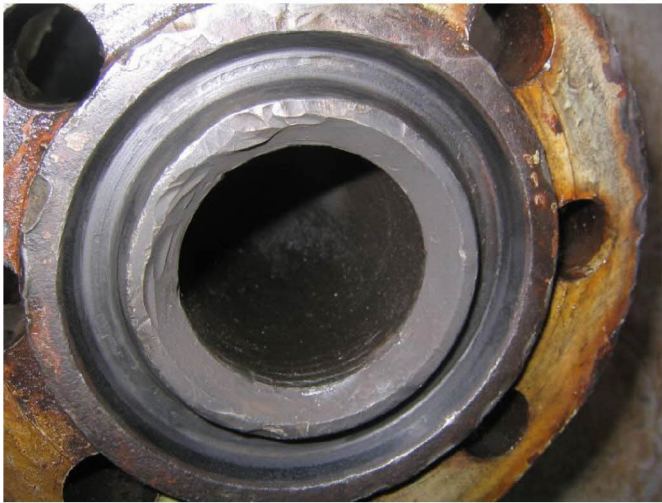
During removal of the thermowells, the nozzle flange gasket surfaces were severely damaged with a hammer. These flanges were lap repaired by a machinist.

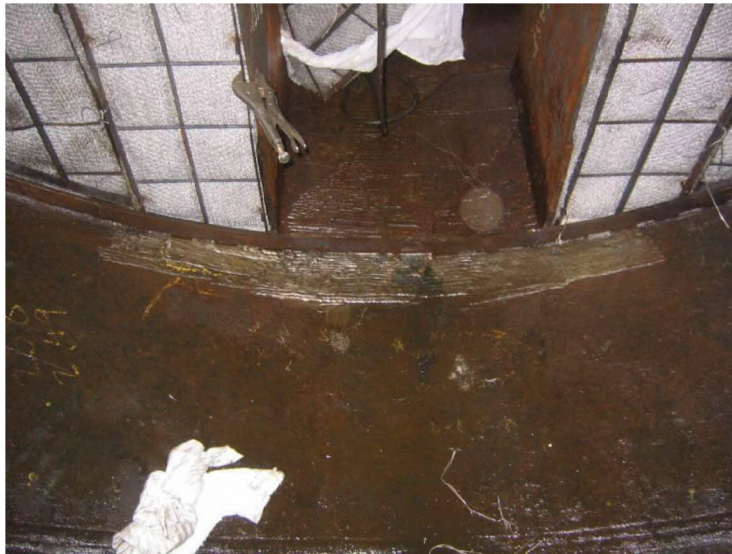
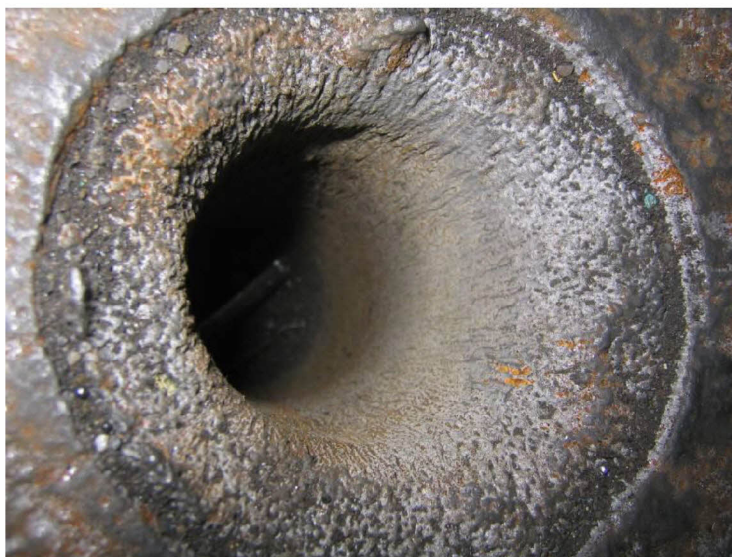
**EXTRA V-430 Shell Weld Overlay
BH305-E2
26200952**

Prior to the shutdown, UT inspection detected a lowest remaining wall thickness (RWT) of 2.120" in the bottom portion of the shell, near the demister pad, of V-430. This value was approaching the Tmin value of 2.018". To prevent further corrosion of the shell in this area, the shell was weld overlaid with 3/16" thick CS weld material.

During the shutdown, it was discovered that the 1-1/2" steam nozzle had pitted corrosion. This area was weld overlaid as well.

During the shutdown, it was found that a lesser amount of area needed to be weld overlaid behind the demister. However, the area beneath the demister pad required weld overlay.

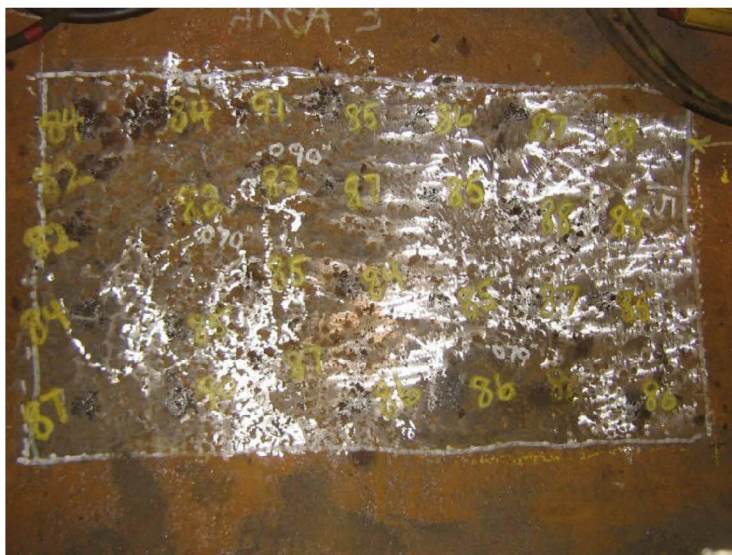
During the shutdown, V-440 was opened for inspection. No work was originally planned for this vessel. During inspection, some localized pitting was found. A meeting was held to determine a plan of action.

First, it was found that the SIS had an incorrect T_{min} value. The SIS T_{min} was calculated by simply subtracting the corrosion allowance from the original thickness. The actual T_{mins} were calculated (Shell = 0.685", Head = 0.680") and the SIS was updated.

The lowest thickness found while pit-gauging was 0.800". The NHT has seen outrageously high corrosion rates over the past 5 years, but process controls (pH monitoring, water injections, etc.) have been installed to reduce these rates. Even when using the high rates, it will take 6 years to reach T_{min}. Based on the long term corrosion rates, the vessel has 25 years of life remaining.

Based on this data, it was concluded to prepare the internal surface of the vessel to obtain good UT readings on the run. The vessel can be safely operated without restrictions until the next shutdown.
